Case Number: S2023000024 Rev A

Symptom/Vehicle Issue: Water Leak Rear Of Cab Rear Seat Or Headliner

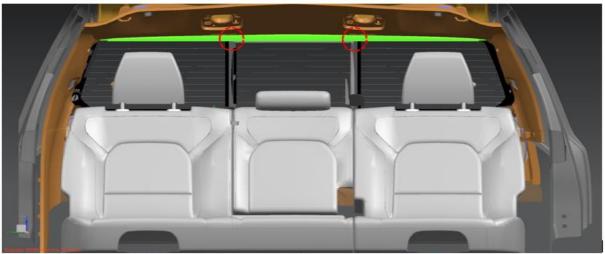
Discussion: Inspect backlite (rear window) upper plastic frame for cracks. If part shows visible marking near red circles in Figure 1, run fingernail across suspect area.

Figure 1 - Inside Truck Cab, Light Green Part is Upper Plastic Frame of Backlite, Red Circles are Potential Crack Locations

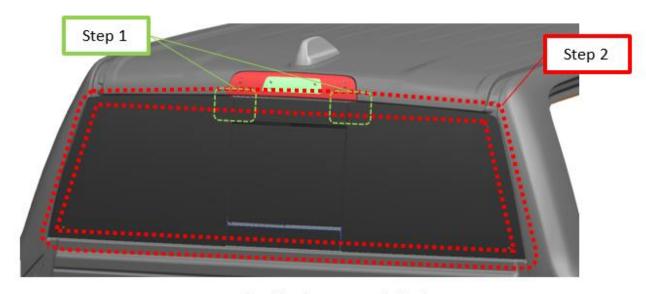
- Incorrect urethane seal around backlite. Bubbles or pockets in the urethane.
- From 3rd Brake Light (Center High Mounted Stop Lamp)
- From Antenna

Figure 4 - Areas of Backlite for Water Leak Check

IF Step 1 or Step 2 yields leaks, replace backlite and ensure correct urethane seal.

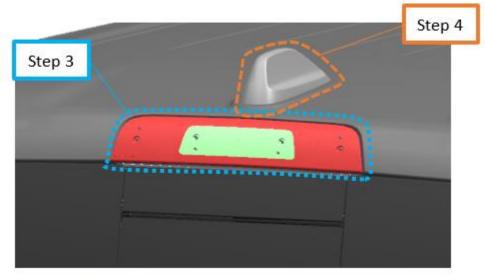
Step 4: Move water hose around roof antenna. Check roof interior for leaks.
Verify foam seal under antenna is in good condition. Verify antenna is torqued to spec

Figure 5 - Areas of Rear Cab for Water Leak Check

IF Step 3 yields leaks, ensure proper torque of fasteners and good condition of rubber seal.

IF Step 4 yields leaks, ensure proper torque of fastener and good condition of foam seal
